Engineering for Polar Operations, Logistics, and Research (EPOLAR)

Component Testing for Modular Pier Replacement at McMurdo Station, Antarctica: Inflatable Pontoon

Gelbo Flex and Full-Scale Cold Storage/Fold Tests

August 2014

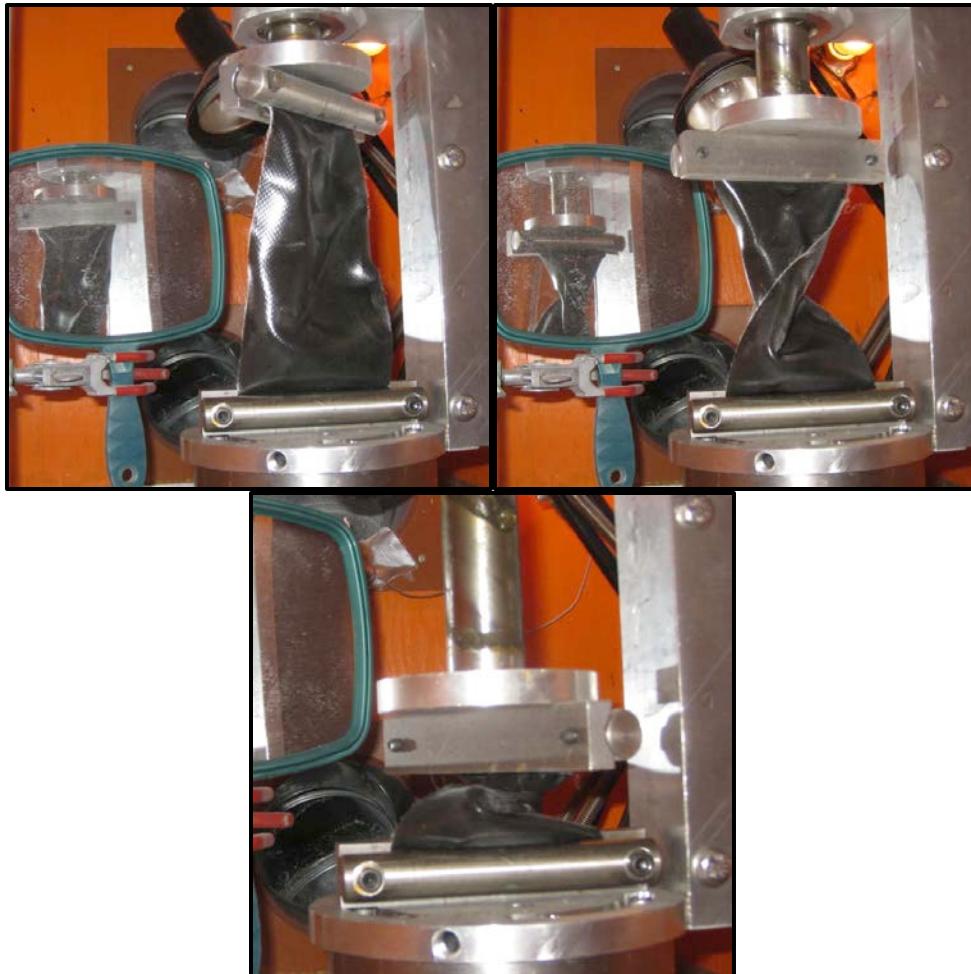
Figure 1. Photo sequence of LMCS pontoon material undergoing Gelbo flex tests at -40°C . The apparatus imposed a 440° rotation during the first 3.5 in. compression, followed by straight compression for 2.0 in. Each cycle took 2 s to compress the specimen and 2 s to reverse the motion (4 s total cycle time). A mirror allowed visual inspection of the back of the specimen without removing it from the apparatus.

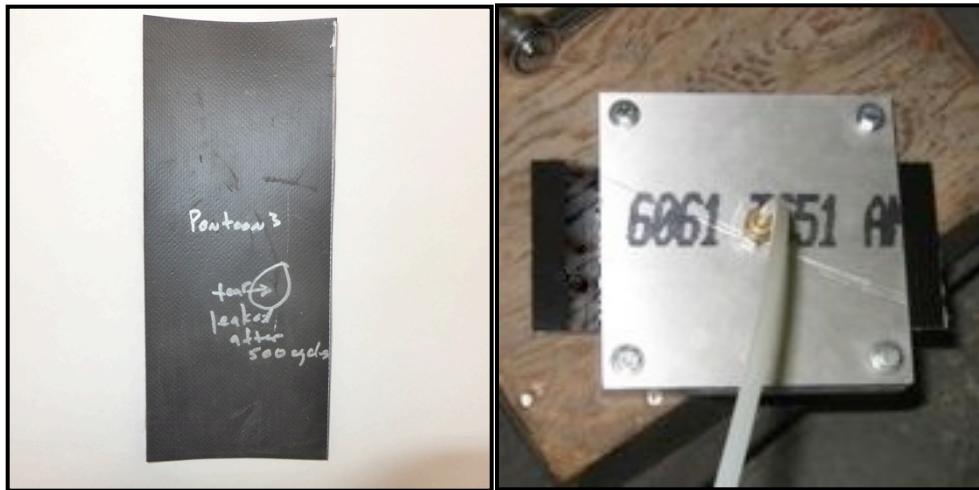
ASTM F392 does not specify how to assess the effects of flexing on the specimens. We chose to use visual inspection followed by an air-permeability test to assess relative flex durability. After conditioning, we visually inspected each specimen for signs of cracking or delamination of the coating from the embedded woven fabric. We marked such regions on the specimen and then conducted a check for air leakage at room temperature. The leakage-test apparatus consisted of two aluminum disks with embedded O-rings, with the upper disk connected to an air reservoir. After pressurizing with air, we sealed off the air reservoir and monitored disk pressure over several minutes to assess the leakage rate (Figure 2). The difference in leakage rates between intact and cracked specimens was readily apparent.

Figure 2. After conditioning material specimens in the Gelbo flex apparatus for a number of cycles, we removed and inspected them for cracks (left) and then clamped over the cracked areas with a leakage-test apparatus to assess failure (right).

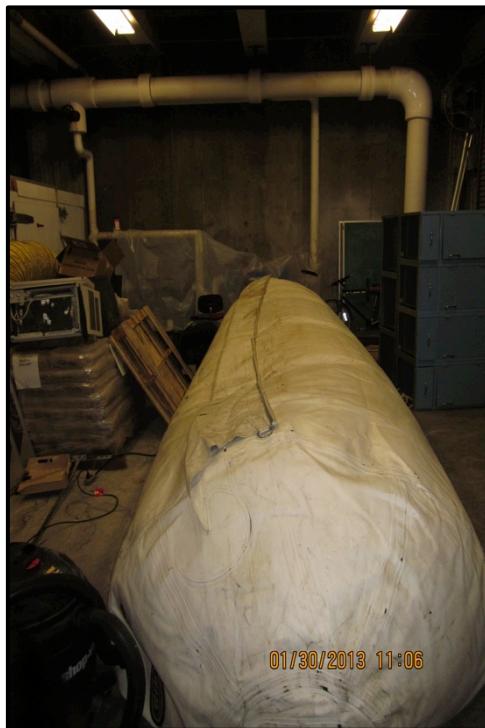
Figure 5. The LMCS pontoon as delivered to CRREL and partially inflated prior to leak identification and patching.

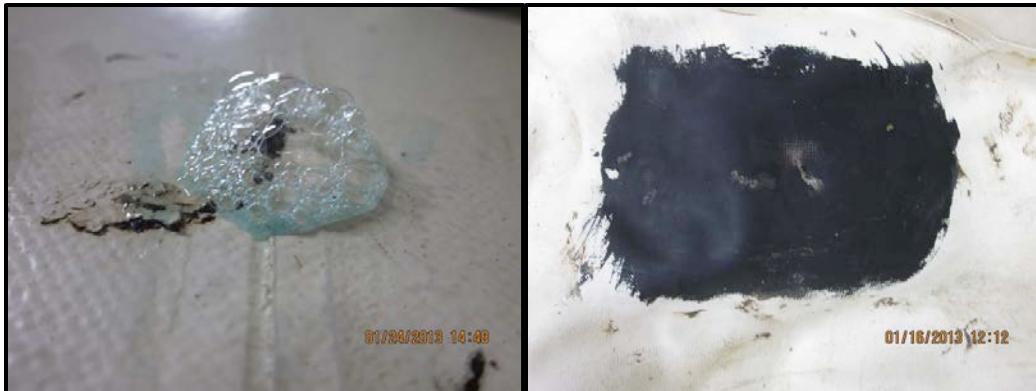
CHL and CSL made a full-scale pontoon available to CRREL for testing. The objective of these tests was to determine whether the folding, cold storage, unfolding, and inflation sequence would have the potential to cause cracking or leaks in the fabric or fabric joint welds. Upon receiving the pontoon, we inflated it and determined that there were 5 leaks caused from prior use as the pontoon was taken from a prototype LMCS that had undergone extensive field testing (Figure 5). Once we identified 4 of the 5 locations using a soap-bubble product and, based on leak rates (rate of bubble production), the relative sizes of the damage, we determined that only the fifth site (identified visually and audibly) was large enough to require patching (Figure 6).

Figure 6. Bubbles forming above a small leak in a thumbnail-sized arc (left), and 2 large gouges at the center of a section prepared for patching (right). The gouges on the right are each approximately the size of a quarter, and the entire prepared area is approximately 8 × 6 in.

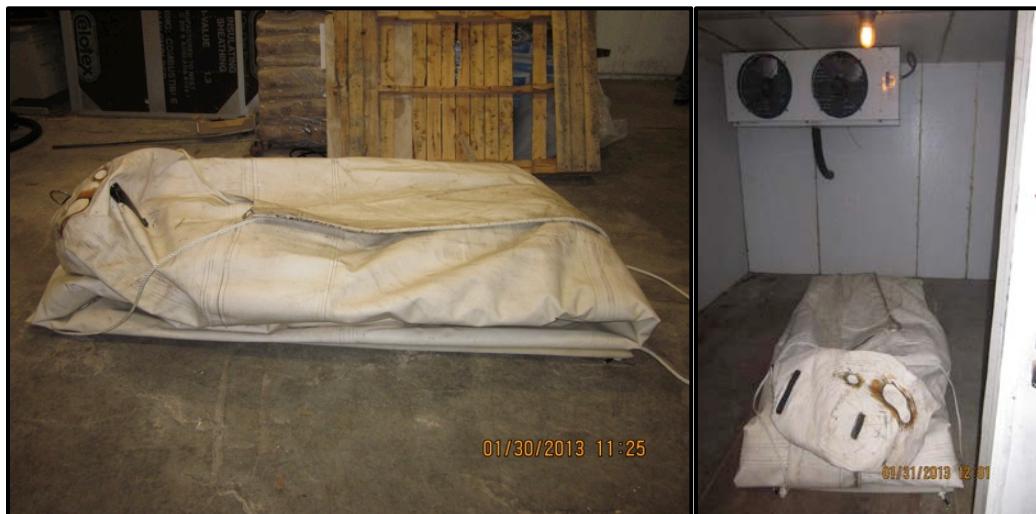
Figure 7. LMCS pontoon tri-folded in 2 directions (left) and ready for cold cycling at -40°C in CRREL's basement cold room (right).

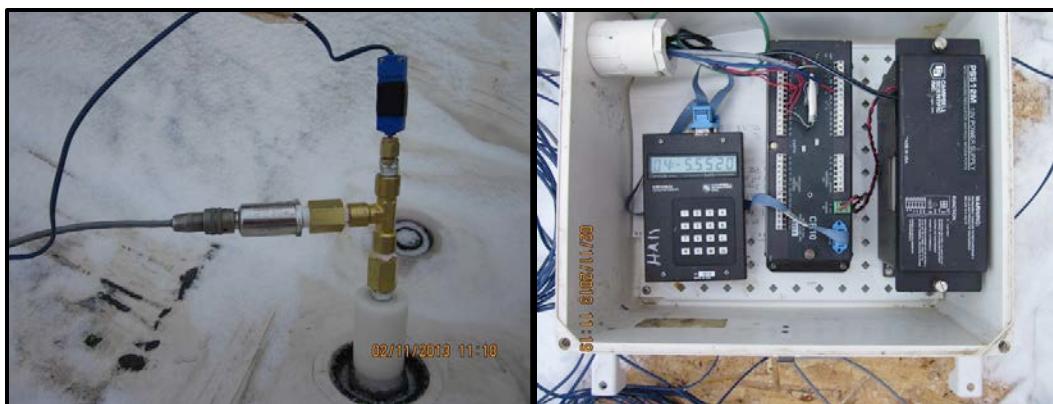
Figure 8. Pressure transducer and thermocouple instruments fitted to the pontoon's pressure relief valve (left) and data monitoring system that measured and recorded the internal pontoon temperature, the external (ambient) air temperature, and the pontoon (gauge) pressure (right).

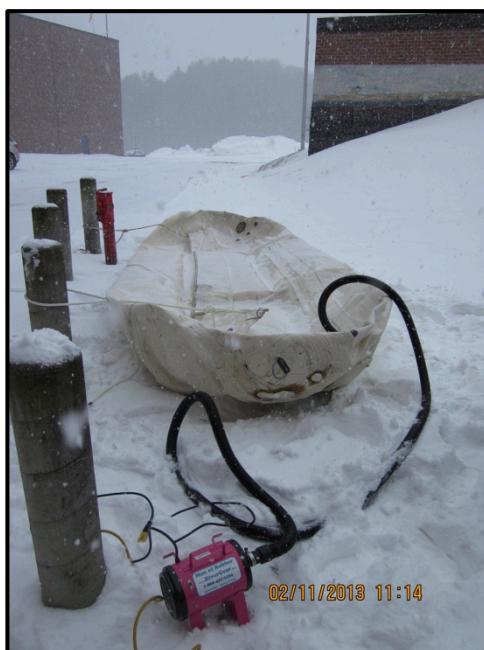
Figure 9. Inflating the LMCS pontoon outdoors during post cold-cycle test 3. Note that instruments are not yet installed in the pressure relief valve at the far end of the pontoon as per Figure 8 above.

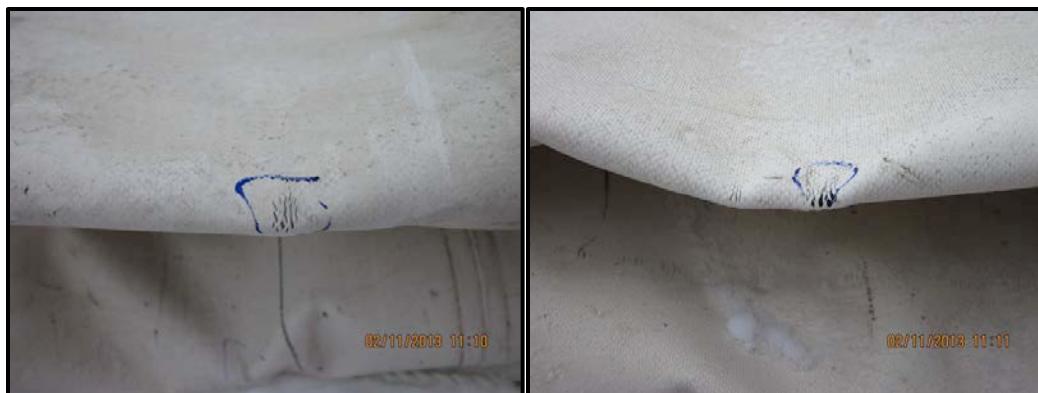
We did find that the white painted-on pontoon coating cracked in fold locations (see Figure 10) during the tests. Note that we attempted to fold the pontoon along the same axes during each cycle to simulate annual cold storage conditions at McMurdo Station. Despite the cracks in the coating, we did not notice any cracks forming in the base pontoon fabric or any increase in size of the existing holes identified prior to the tests.

Figure 10. Cracks in the white painted-on coating formed at the “double-fold” points. We identified these cracks while unfolding the pontoon prior to inflation after Cold Cycle #3. Note that cracks in the coating did not affect pontoon performance.
